RESEARCH MEMORANDUM

PRELIMINARY RESULTS OF NATURAL ICING
OF AN AXIAL-FLOW TURBOJET ENGINE

By Loren W. Acker

Flight Propulsion Research Laboratory
Cleveland, Ohio

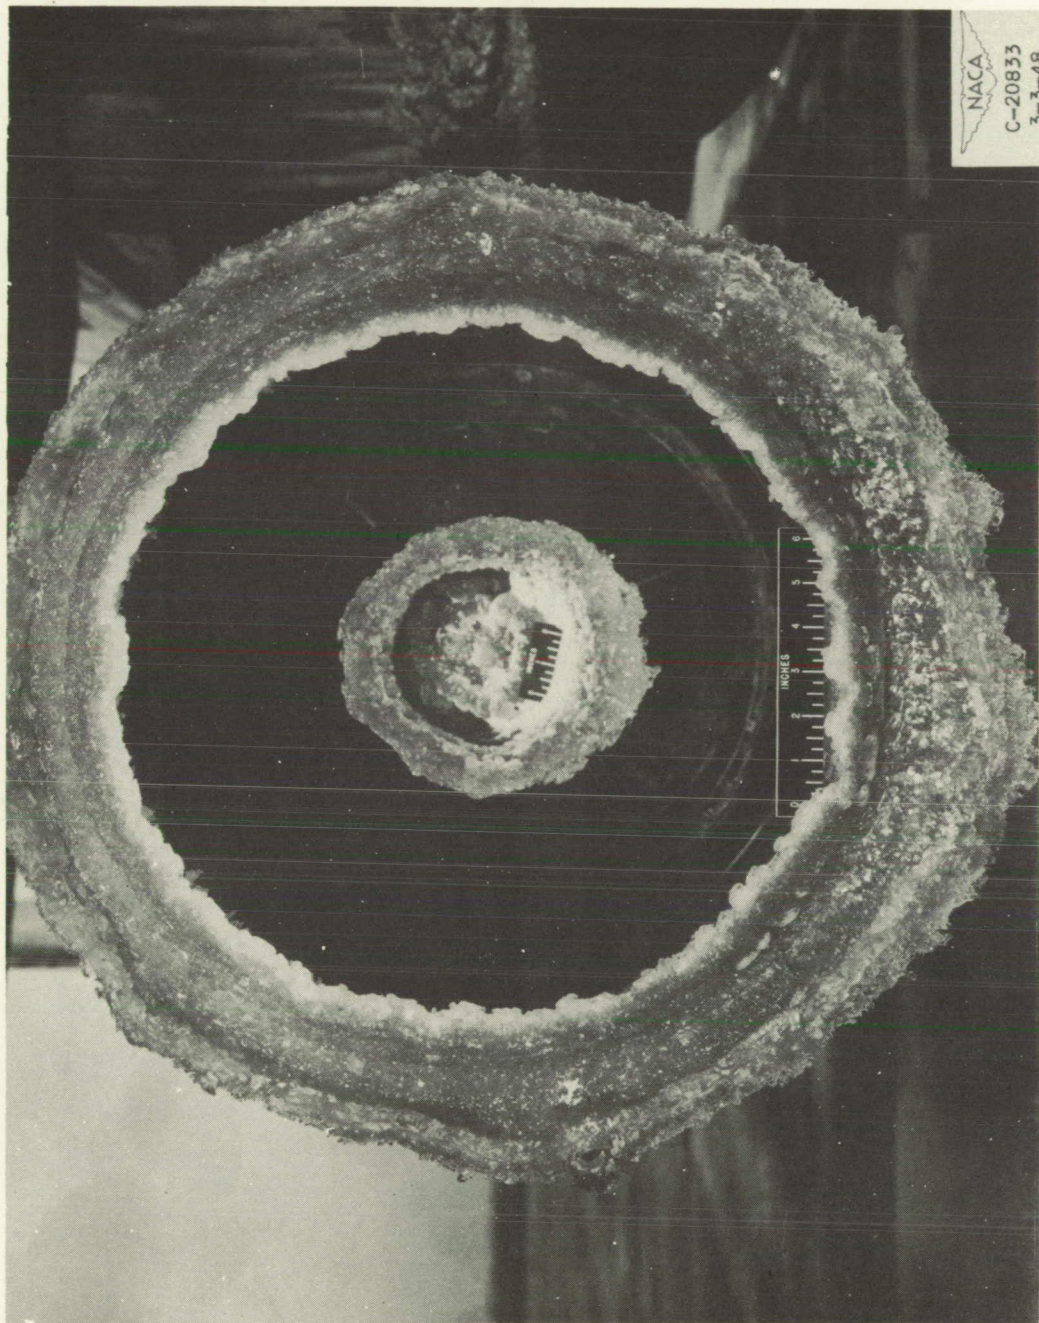
Figure 3. - Ice formation on axial-flow turbojet engine.

Photographs taken after the icing flight are shown in figure 3. A front view of the ice formation on the engine inlet and the starter housing is shown in figure 3(a). The degree of ice accumulation on the engine inlet is indicated in figure 3(b). Ice accumulation on the inlet guide vanes is shown in figure 3(c). Visual inspection of the inlet indicated that ice had accumulated on the first-stage stator blades (fig. 3(c)), the second-stage stator blades, and the first-stage rotor blades. The ice formation on the first-stage rotor blades was concentrated at the leading edge and was approximately 1/8 inch thick. The ice formation on the second-stage stator blades was also concentrated at the leading edge and was approximately 1/32 inch thick and rather sporadic.

(a) Front view of ice formation on engine inlet and starter housing.

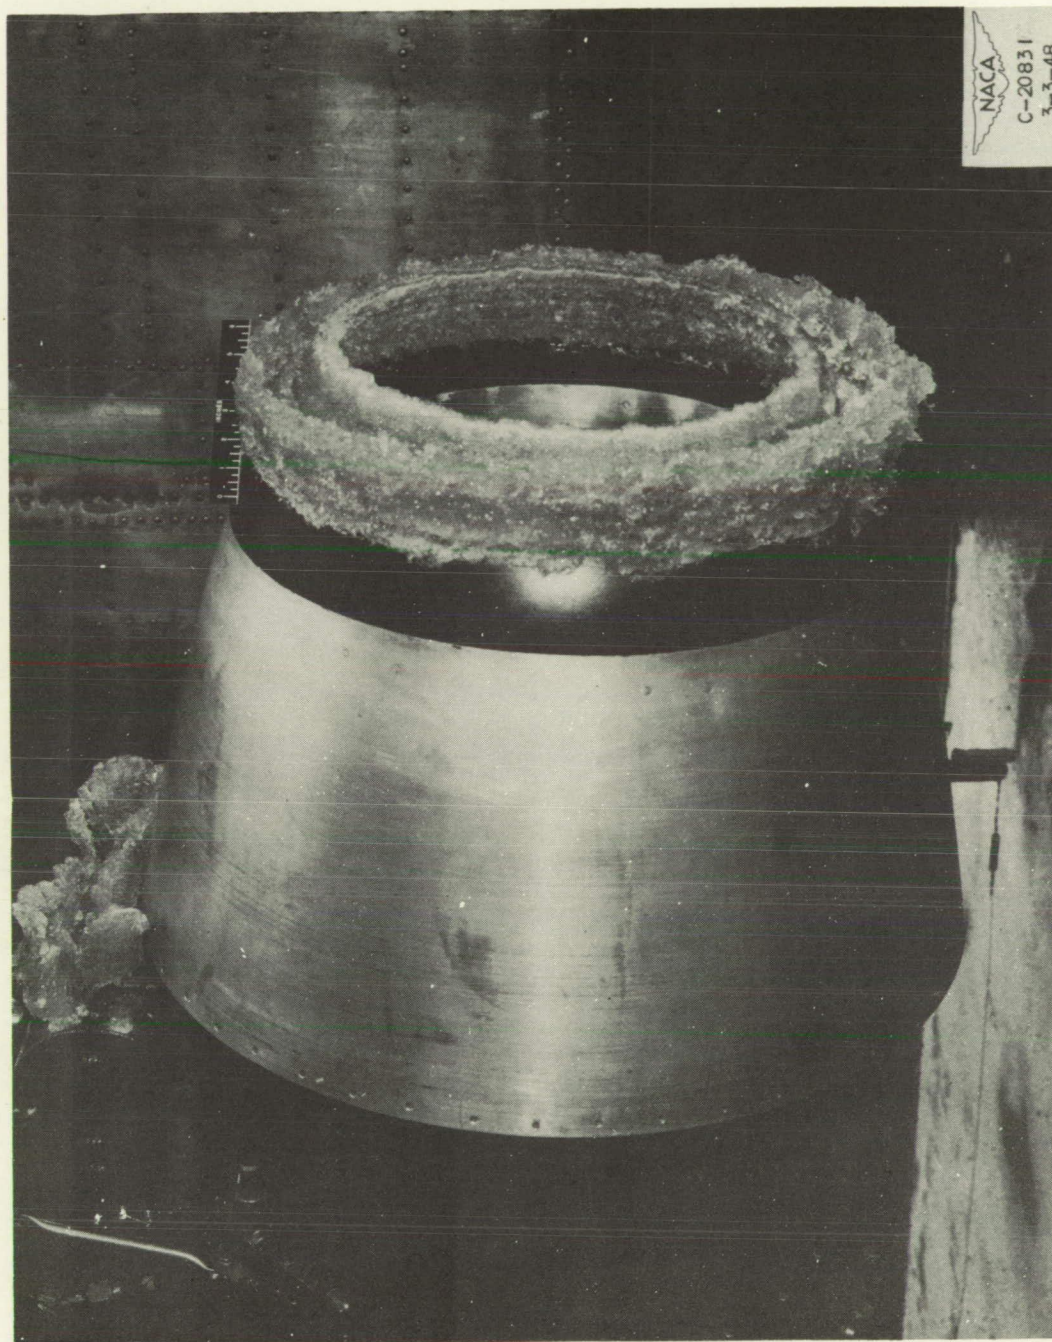
Figure 3. - Continued. Ice formation on axial-flow turbojet engine.

(b) Side view of ice formation on engine inlet.

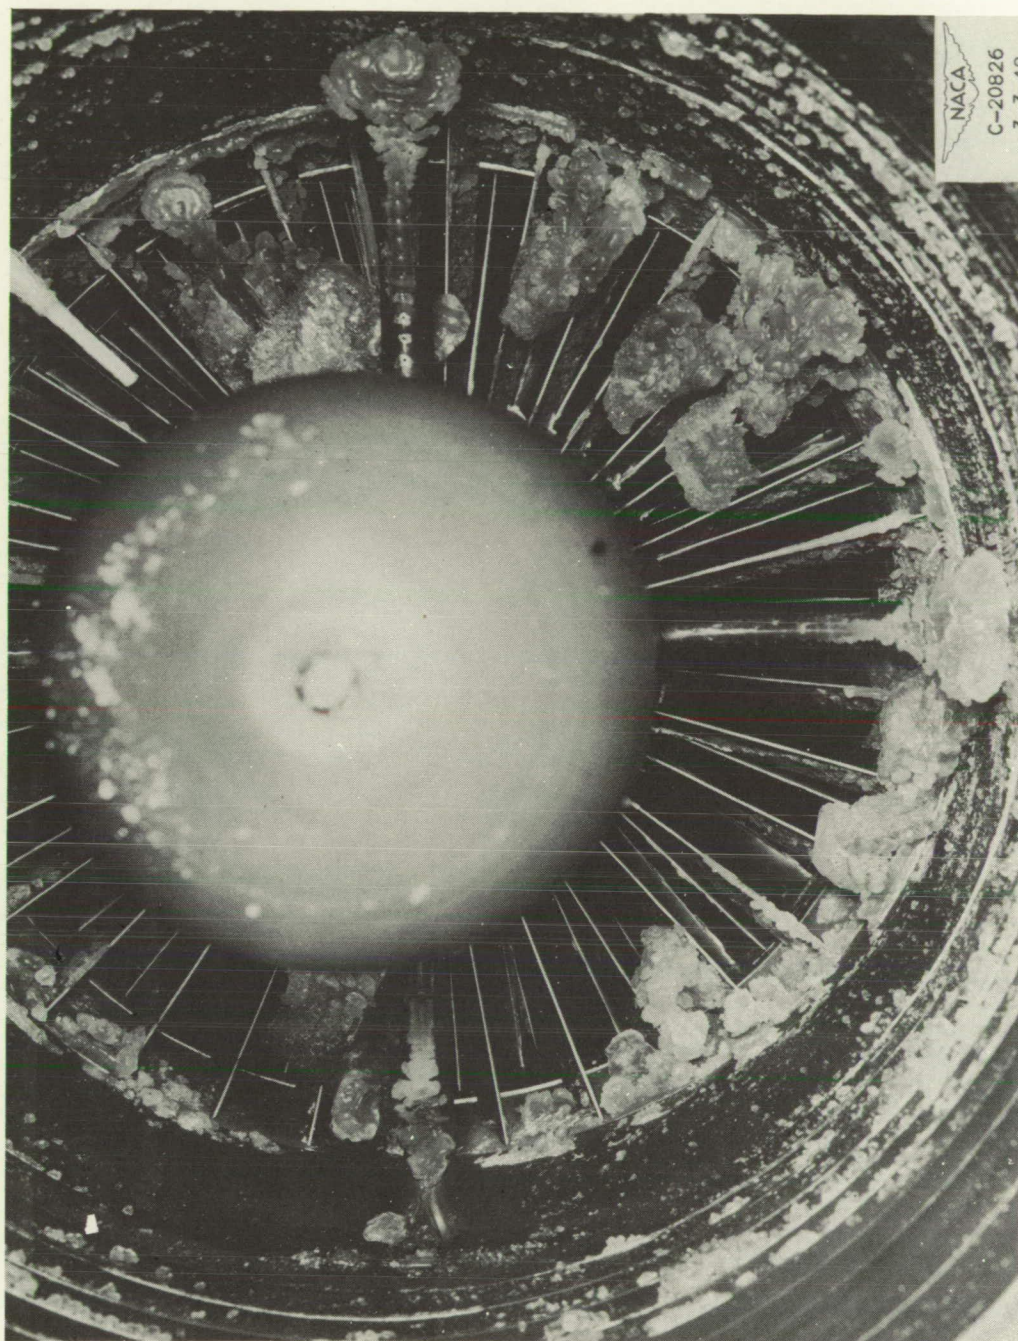
Figure 3. - Concluded. Ice formation on axial-flow turbojet engine.

(c) Ice on inlet guide vanes (ice on starter housing removed).

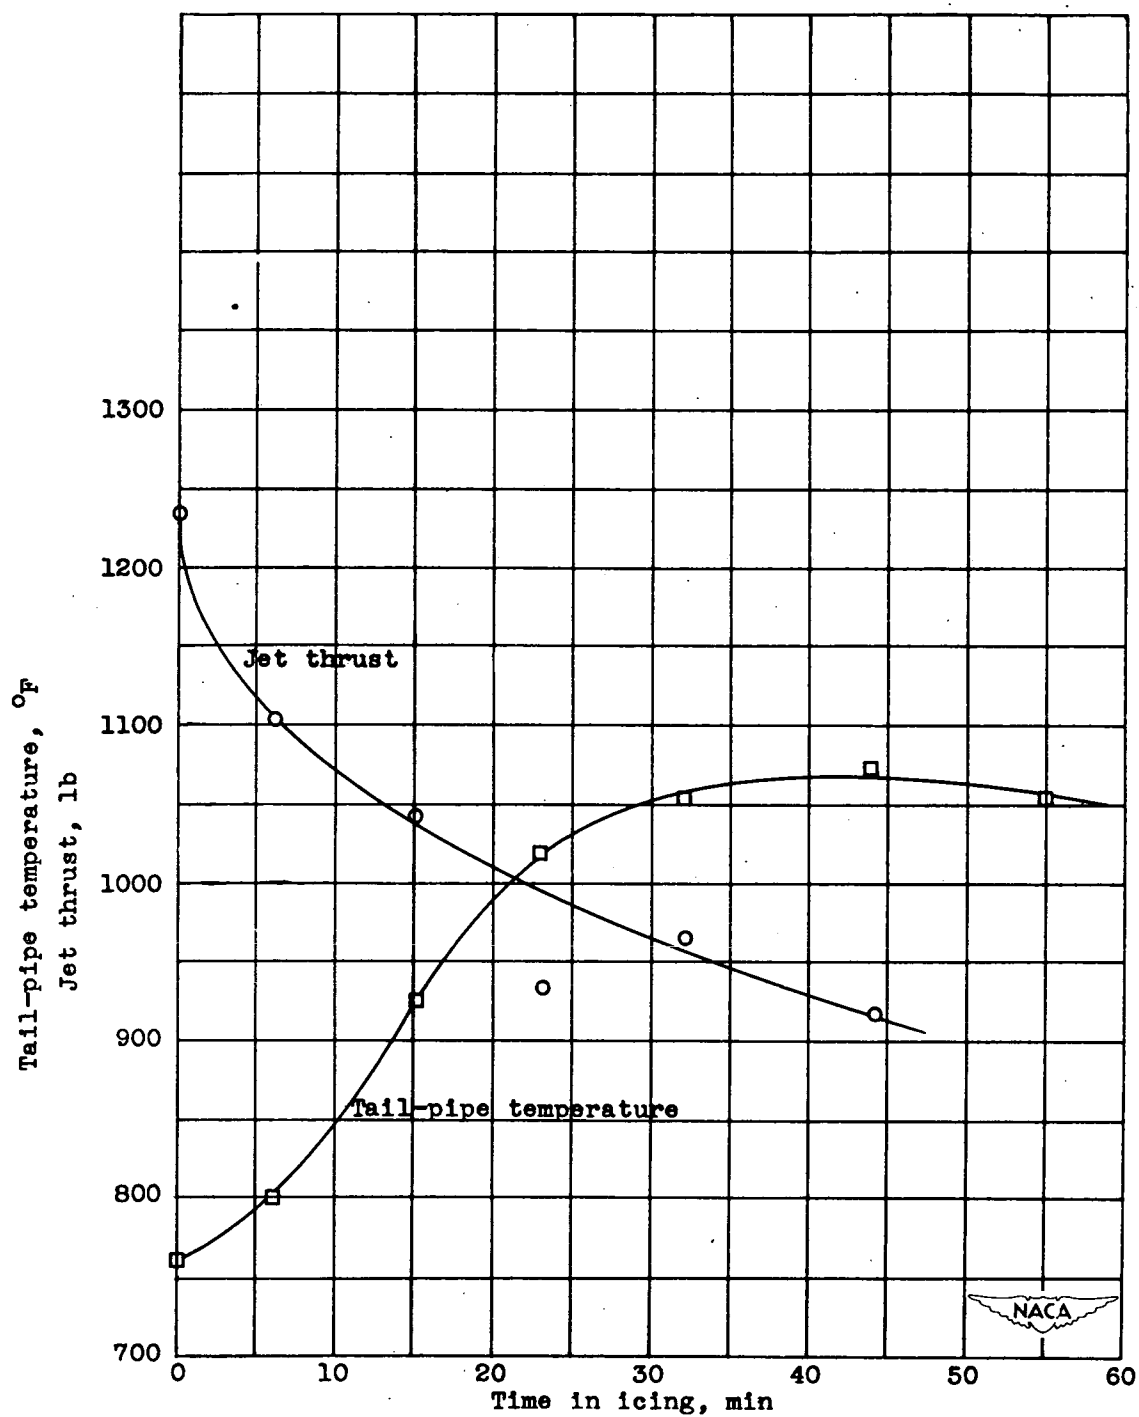
The effect of the ice formation on the engine thrust and tail-pipe temperature is shown in figure 4 as a function of time in the icing condition. The engine was operated at a speed of 9000 rpm in an icing condition for approximately 1 hour. Engine data were taken before the icing cloud was entered and periodically during the encounter with the icing condition. At the end of 45 minutes, the engine thrust had decreased from 1234 to 910 pounds, a reduction of approximately 26 percent. After 45 minutes, the tail-pipe temperature had reached its maximum rise from 761° to 1065° F. At this point during the encounter, the tail-pipe temperature appeared to stabilize. The greatest decrease in thrust and increase in tail-pipe temperature appeared to occur in the first 15 minutes of the encounter.

Figure 4. - Effect of time in icing condition on engine jet thrust and tail-pipe temperature at engine speed of 9000 rpm.
